NASA TM X-2180

PERFORMANCE OF CERAMIC
INSULATOR SEALS AT HIGH
NEUTRON AND GAMMA FLUENCE LEVELS

*by Robert G. Rohal, Thomas N. Tambling,
and Roger L. Smith*

*Lewis Research Center
Cleveland, Ohio 44135*

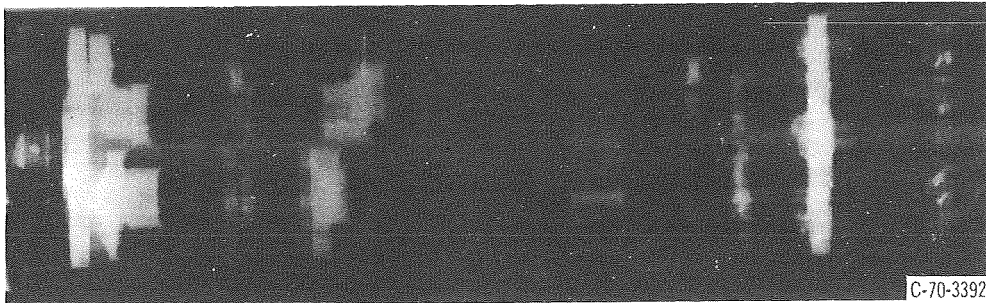
Neutron radiographs. - As previously mentioned, neutron radiographic surveillance was used mainly because it is an acceptable and relatively easy method to detect the presence of water in the evacuated chambers (ref. 3). The radiographs taken are shown in figures 6 to 10. If the chamber contains no water, the neutrons passing through it will not be affected and as a result the photograph will be exposed in that area (appears dark in figs. 6 to 10). If the chamber has water in it, the neutrons passing through the chamber will be affected (either absorbed or scattered) and as a result the photograph will not be exposed in that area (would appear as white in figs. 6 to 10). The neutron radiographs taken after 250, 550, and 960 hours of irradiation (figs. 8 to 10) showed no evidence of water leakage through the seals and into the chambers.

Figure 8. - Neutron radiograph of capsule assembly after 250 hours of irradiation.

Figure 9. - Neutron radiograph of capsule assembly after 550 hours of irradiation.

Figure 10. Neutron radiograph of capsule assembly after 960 hours of irradiation.

The test assembly was removed from the reactor and neutron radiographed after each 200 to 300 hours of irradiation until the test was completed. The radiographs were taken to show any evidence of water leaks past the seals into the evacuated chambers. The results are discussed in the next section. The test assembly was then removed to the hot lab for post-irradiation examination.
